## **Arboricultural Impact Assessment**

## **Yale Campus Redevelopment - Coleg Cambria, Wrexham**

Our Ref: 17/AIA/WXM/201

July 2018

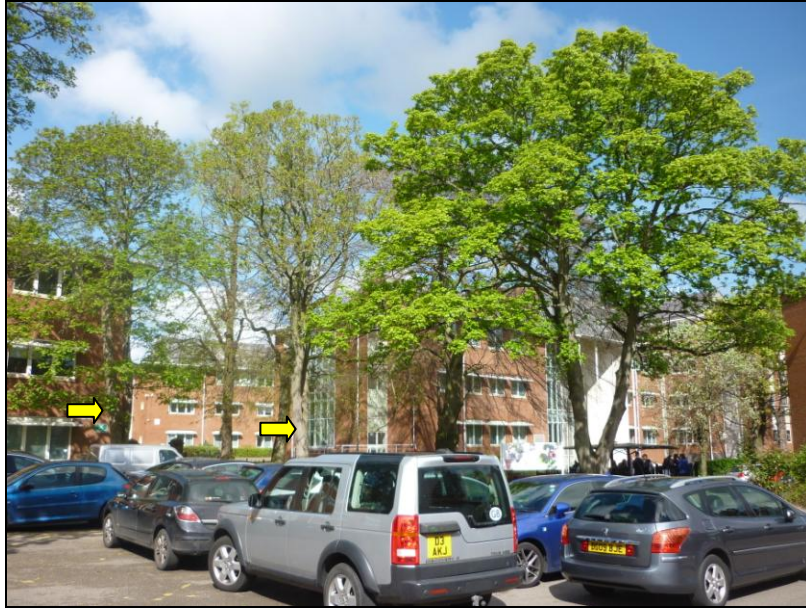
- 8.2 Whilst unnecessary to accommodate the development we have also recommended the removal of tree number 7 as it is showing signs of stress and decline. Removing this tree will open up a clear vista to tree numbers 4, 5, 6 & 9 which are far better quality specimens that provide high amenity and landscape value within the college grounds. We would recommend this appropriate tree management works irrespective of the development proposal.

**P1 - Tree numbers 7 & 8 to be removed leaving attractive group of T4-6 & T9**

- 8.2 In order to accommodate the proposed development it will be necessary to remove tree numbers 8, 10-12, 17-23, 34-39 & G1, G3. Removal of T8 will be mitigated by retention of the better quality tree numbers 4-6 & 9, tree numbers 10-12 are not particularly good quality specimens and are not visually prominent. Tree numbers 17-23 & G1 are semi-mature/early mature Alders planted by the college as landscaping associated with the previous development works. Whilst they do offer some visual amenity to students and staff, their retention value is disproportionate to the value of the new proposed campus. Furthermore, these trees will all be replaced by new planting that will suitably mitigate for their loss. Tree number 34 is a past coppiced Sycamore of no particular merit and T35 & 36 are past topped/pollarded Limes with extensive basal decay and as such require considerable remedial management irrespective of this development proposal. G3 are mixed overgrown/unmanaged evergreen shrubs that provide screening that would no longer be required after the new building is erected and T37-38 are dark oppressive trees that are causing damage to the boundary retaining wall. Removal of these trees will allow much needed light and space along this heavily tree lined boundary and also provide scope for some attractive new landscaping as part of the main pedestrian entrance to the campus off Chester Road. T39 is now a 3m stump of no value and should not form a material consideration of this application. This tree will be replaced by a specimen Ginkgo or similar.

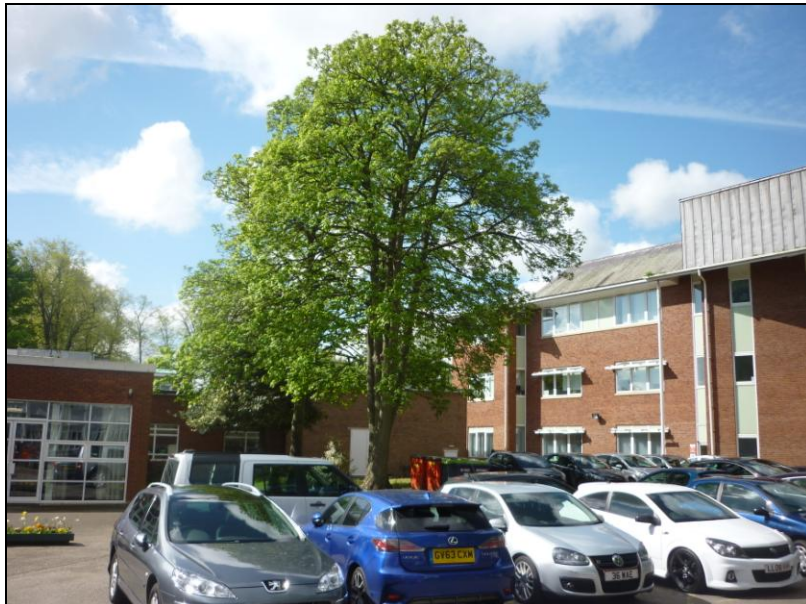
**P2 - Tree numbers 10-12 to be removed**

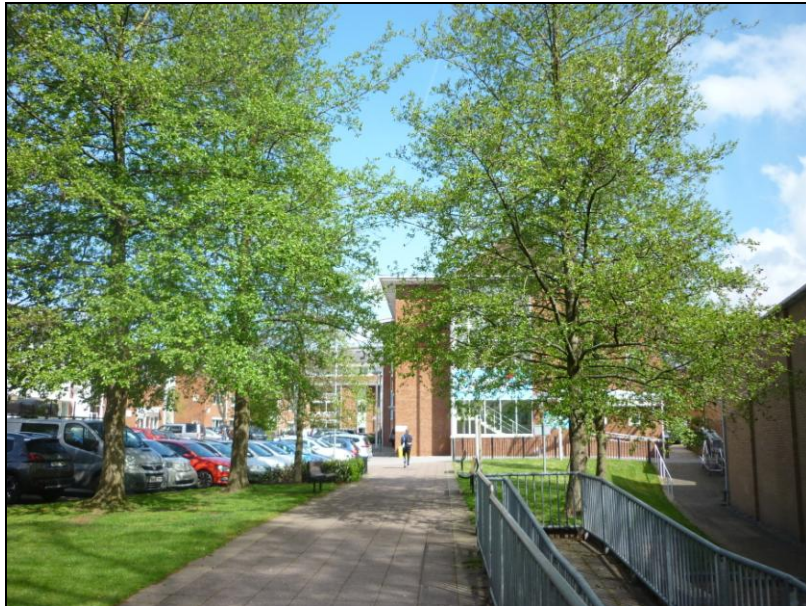
**P3 - Tree numbers 17-22 - semi-mature Alders to be removed**

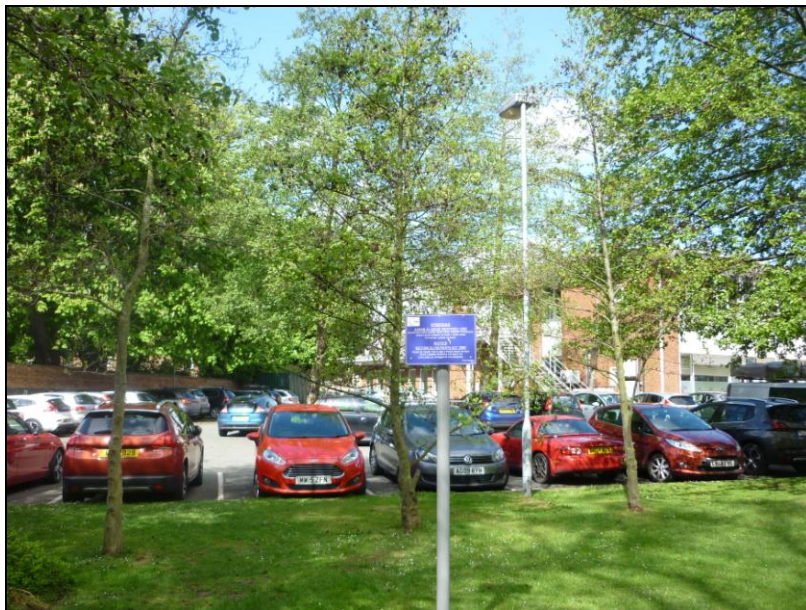
**P4 - G1 - low grade Alders of no value to be removed for development**

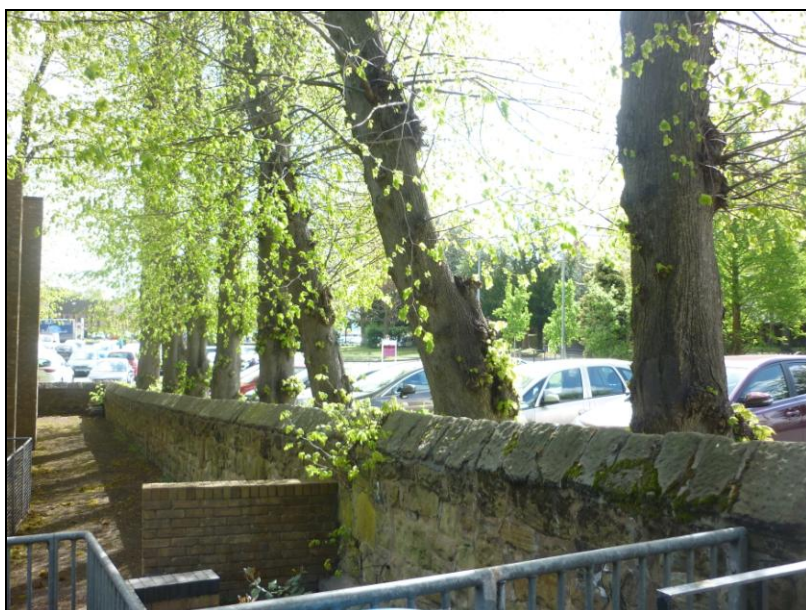
**P5 - G2 - Lime avenue beyond boundary wall - small diameter secondary growth to be reduced back over site to prevent damage from demolition works & create easement to new building. Area beyond wall fenced off during all works to prevent root damage**

- 8.3 Access facilitation pruning will be required to the overhanging canopies of group 2 and tree numbers 24-32. As the canopies of group 2 have been reduced and lifted many times in the past as ongoing maintenance work this proposed pruning works will have no adverse effect on the health and vigour of the trees or the amenity value they afford to the area. Pruning to tree numbers 24-32 will be kept to the minimum required to erect scaffolding and provide a minimum 2m easement to the new building.

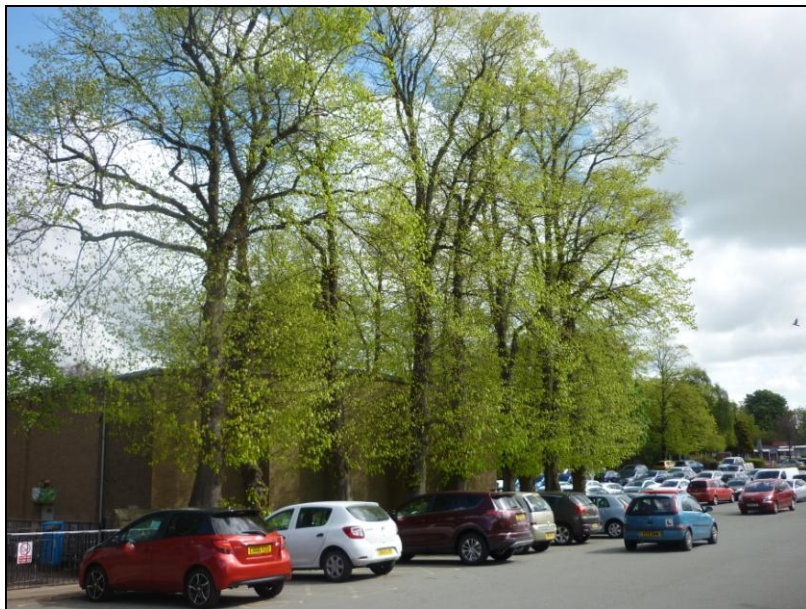
**P6 - Close proximity of G2 to existing building**

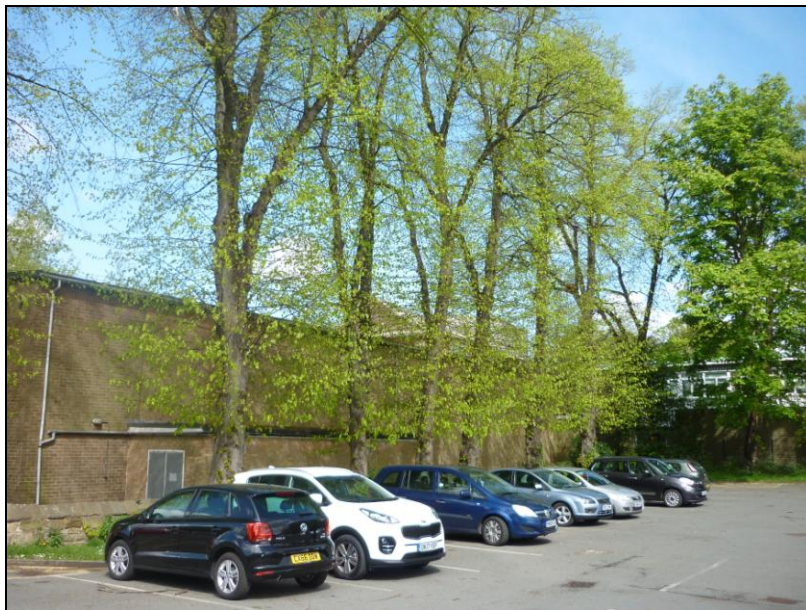
**P7 - Eastern section of G2 - note past crown lifting & reduction work**

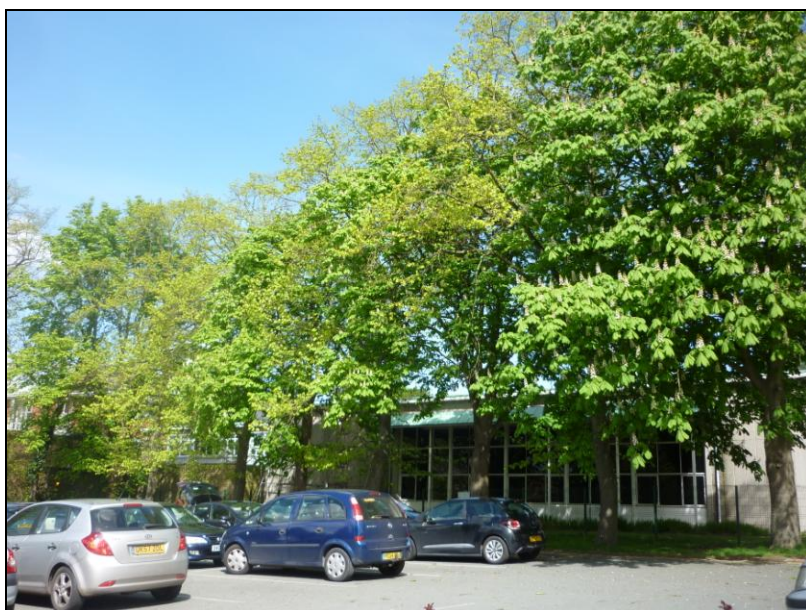
**P8 - Tree number 24-27 viewed from council car park**

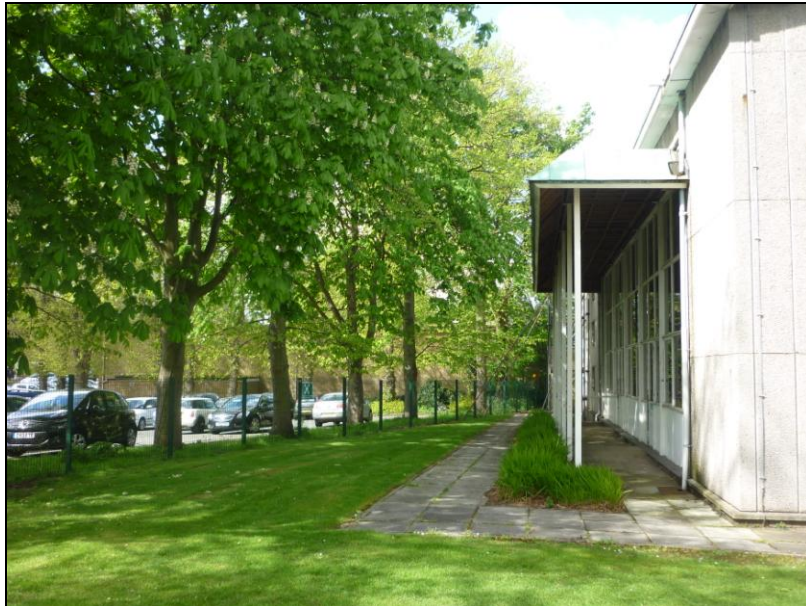
**P9 - T24-T30 viewed from within the site. Canopies to be pruned back where necessary to provide a minimum 2m easement to new building**

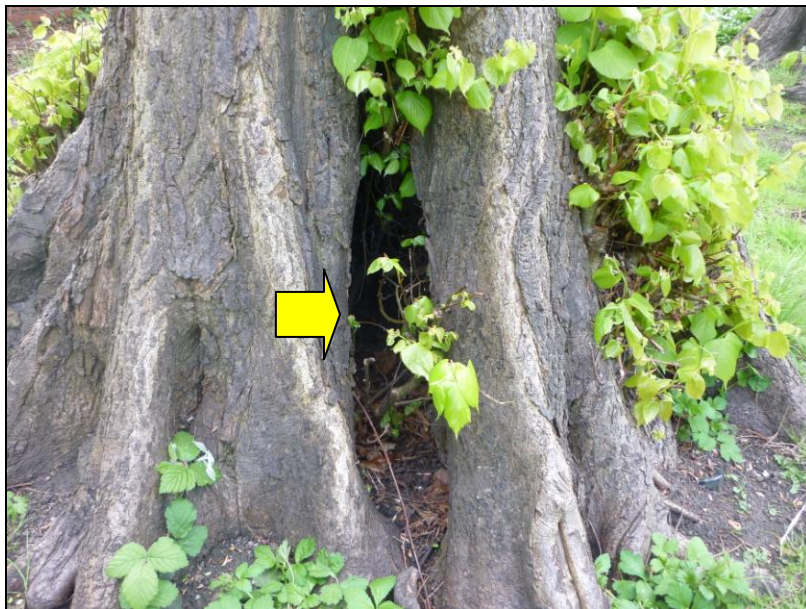
**P10 - Decay cavity at base of T35. Entire base of stem is hollow**

TREE NO. <small>T - Tree G - Group H - Hedge W - Wood</small>	SPECIES (COMMON NAME)	AGE	HEIGHT (m) + CROWN CLEARANCE/ DIRECTION OF GROWTH (N.S.E.W)	RADIAL CROWN SPREAD (m)				STEM/ MULTI-STEM* DIA.(mm)	VITALITY	COMMENTS	MANAGEMENT	CATEGORY & SUB- CATEGORY GRADING BS 5837	BS 5837 RADIUS (m)  RPA (m <sup>2</sup> )
				N	S	E	W						
T32	Lime	M	17 1S	5	5	4	3	490	G	<ul style="list-style-type: none"> <li>No visual defects</li> <li>E.R.C. 40</li> </ul>	• As T25	A2	5.8  109m <sup>2</sup>
T33	Lime	M	17 1S	5	5	5	2.5	560	G	<ul style="list-style-type: none"> <li>No visual defects</li> <li>E.R.C. 40</li> </ul>	• As T25	A2	6.7  142m <sup>2</sup>
T34	Sycamore	EM	13 2W	2	4	4	4	210x5 (470)	G	<ul style="list-style-type: none"> <li>Multi-stem from past coppice</li> <li>Offers greenery along Chester Rd</li> <li>E.R.C. 20</li> </ul>	• Remove	B2	5.6  100m <sup>2</sup>
T35	Lime	FM	18 0.5E	4	4	4	5	810	G	<ul style="list-style-type: none"> <li>Topped/pollarded at 12m leaving large wound with decay column below &amp; secondary crown above</li> <li>Hollow butt</li> <li><b>Potential hazard</b></li> <li>E.R.C. 20 (depending on management)</li> </ul>	• Remove for development & replace with specimen tree - see landscape plan	B2	9.7  297m <sup>2</sup>

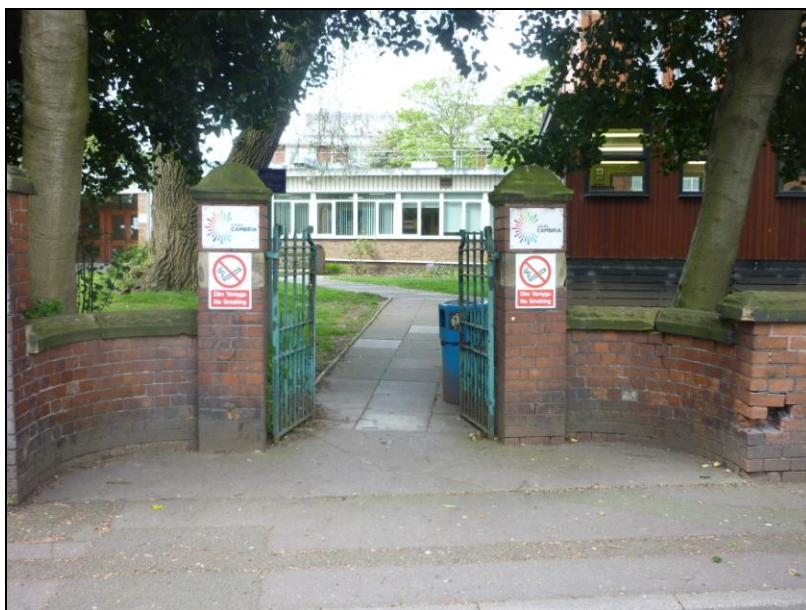
**P11 - Base of T37 & T38 abut existing boundary wall causing displacement. Trees appear dark & oppressive - removal will open up the area & allow for some new landscape enhancement works**
